ERDC/CRREL TR-03-17

Design and Operational Issues While Tunneling in Firn at the South Pole Station

Michael Walsh

September 2003

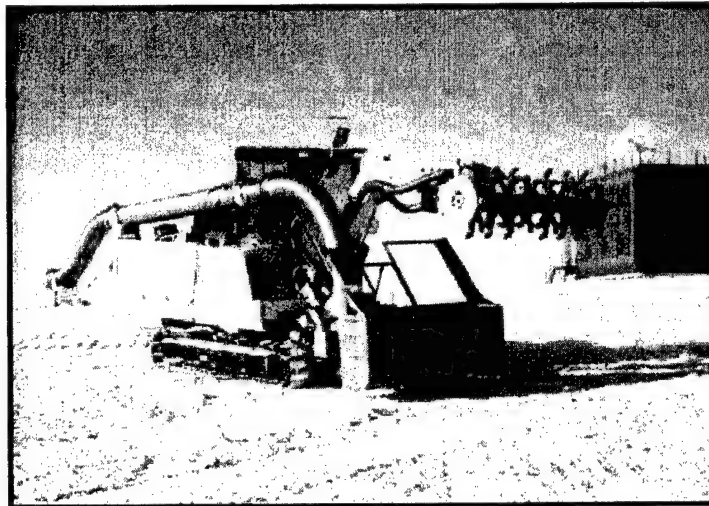
Figure 3. Tunneling machine (photo, M.R. Walsh).

The tunneler proved to be underdesigned for the conditions initially encountered at the South Pole. The biggest factor was the higher than expected snow strength attributable to the increased tunneling depth specified upon our arrival. The snow strength that was used in the tunneler design calculations was 0.5 MPa. This was based on an anticipated depth of 9 m and undisturbed snow compacted through natural mechanisms (Gow and Ramseier 1964, Mellor 1964). However, the actual depth of the tunnel was up to 16 m and the area into which the tunnels were driven was highly disturbed and thus more compacted and stronger than anticipated. The difference in strength for these conditions is substantial, over twice that for undisturbed snow. The power required to meet the production goal

(3 m/h) thus went from 8 to about 25 kW. Concurrent with the power, higher torque is necessary to machine the snow and maintain the production rate. The available torque at the drum with the system as originally designed limited the possible depth of cut. In very hard material, approaching the consistency of ice in places (density greater than 800 kg/m^3), the depth of cut was limited to 0.05 m instead of the 0.24 m used under the original design conditions. In 1997, following the analysis of the South Pole tunneling operations in 1996, a 19-kW hydraulic pump was specified to replace the original 10-kW pump. This pump is the maximum size compatible with the original drum drive system. However, a 23-kW pump was shipped by the supplier and installed for testing and training in 1999. This pump was inadvertently left on the unit, overdriving the drum and causing premature failure of the drum drive components in subsequent tunneling operations.

Problems with the hydraulics in general and the drum drive in particular have been examined to a great extent. It is obvious the drum drive was underpowered for the conditions encountered during the tunneling operations. Both a larger hydraulic drive and an electric drive have been considered to power the drum. As the system currently sits, the final chain drive is rated at 16 kW continuous duty. Using a 15% intermittent duty factor, the largest system drive that can be considered is around 18 kW, 23 kW before inefficiencies. Although still undersized (a 23-kW final drive is more suitable), this is a workable system that will not require a major redesign. Going to a larger hydraulic drive system will require the redesign of both the hydraulic and mechanical aspects of the drum drive. An electric drive would weigh in excess of 250 kg and require a major redesign of not only the drive but the supporting mechanism of the drum. The most workable solution for the current system therefore is to reinstall the 23-kW drum drive pump and replace the current drum drive motor with a larger displacement, higher torque model that will directly output the desired speed. Care needs to be exercised prior to cold start to reduce damage attributable to high oil viscosity. Pre-warming the hydraulics with a heater or leaving the hydraulics circulating between shifts will help alleviate the problem.

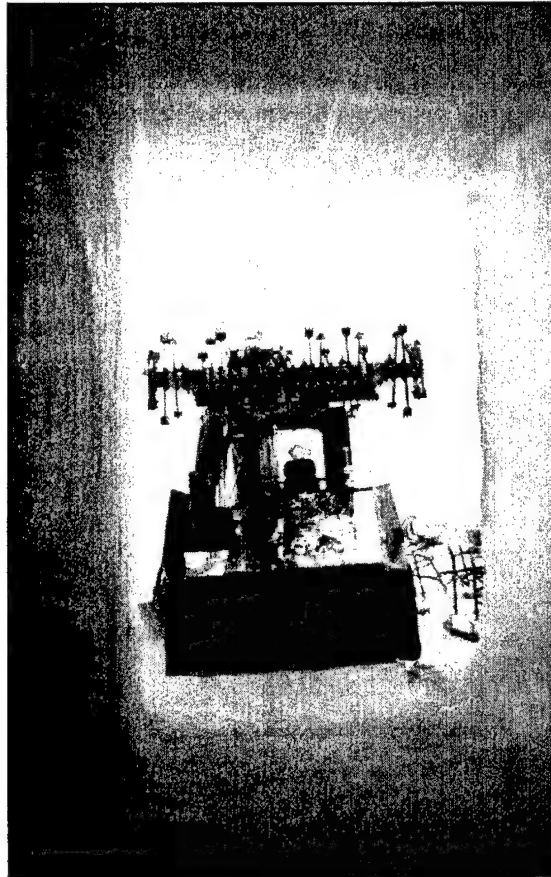
Figure 4. Front of tunneling machine showing snowblower (photo, M.R. Walsh).

A second problem associated with the center-impeller snowblower is the stress on the joint where the ejector tube meets the snowblower. The ejector tube is unsupported from the snowblower to the end of the tunneler (up to 7 m), with a sliding joint and a large-radius 100° elbow between. When the snowblower is

lifted or lowered, extended or retracted, high stresses are experienced at the snowblower joint. In addition, the uneven distribution of weight adds stress to the lift/extension frame for the snowblower. Both assemblies failed several times and were modified. Some problems still persisted, although they may be attributable to overuse of the system.

The speed and torque of the snowblower impeller are too low. Because of the configuration of the throat, an attempt was originally made to meter the snow into the airstream through the throat to avoid clogging. This did not prove successful. Higher rotational speed and more torque will be necessary to give the debris enough momentum to fully engage the airstream. This should improve the efficiency of the disposal system.

The ejector tube connection point failure at the snowblower was a recurrent problem that was addressed but never fully resolved. The stresses at that point are quite large, and the joint is stressed often during operation. It was redesigned and rebuilt twice, resulting in increased reliability, but the joint will have to be reexamined if the system is to be used again.

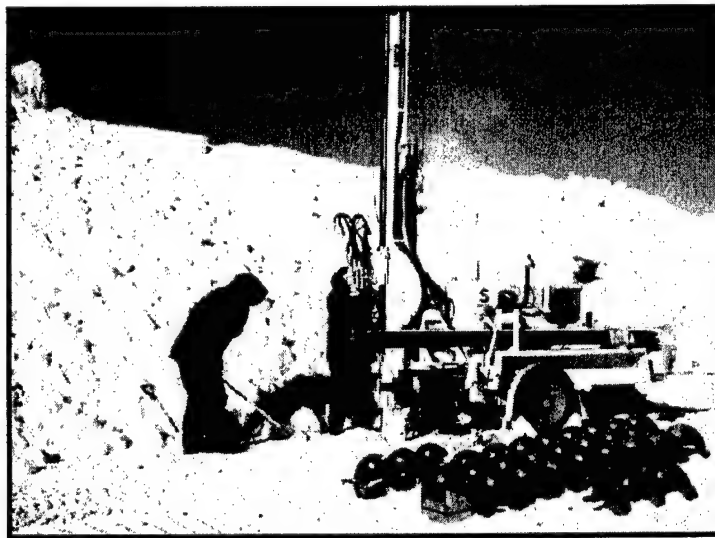
Figure 5. Drill rig used at pole (photo, M.R. Walsh).

The drill rig (Fig. 5) did not operate in the cold as well as expected. Starting the unit was very difficult, even with a block heater and hydraulic oil heater. When back boring the 1-m diameter escape shafts, the drill string tends to whip violently as the bit approaches the surface. This becomes especially dangerous when the bit breaks through. Varying the drilling parameters had little effect on this behavior. A means of stiffening or stabilizing the rod needs to be found and implemented.

Starting problems with the mobile drill in the cold were resolved by warming the unit for longer periods with a mobile heating unit. This did not fix the problem of cold starting but it was a work-around. The hydraulic reservoir is equipped with heaters, but the oil temperature was too low for efficient operation. Adding an insulated cover to the tank resolved this problem.

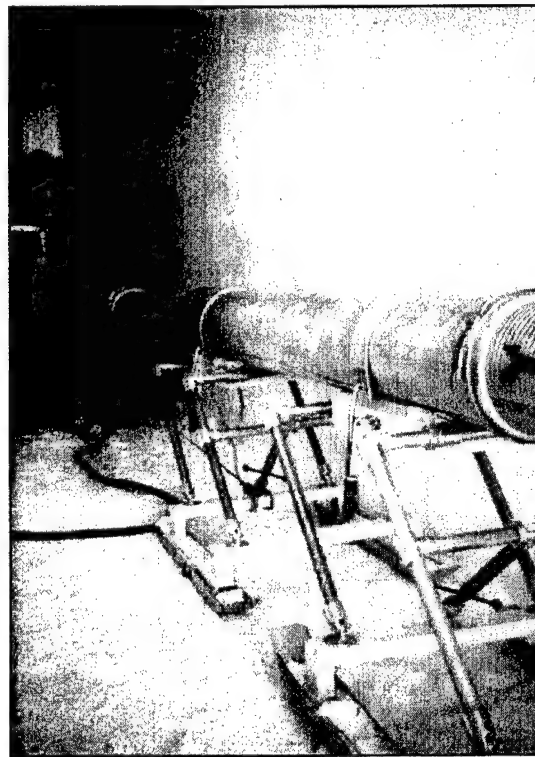
Figure 6. Single-expansion duct unit mounted to tunneler (photo, M.R. Walsh).

The problems associated with the remainder of the debris transport system were successfully addressed. Stressing of the horizontal ducting during the frequent positioning of the tunneler were resolved with the fabrication of a short single expansion duct unit that was mounted directly behind the tunneler (Fig. 6).

This unit is much lighter than the regular double expansion units and runs much smoother. The hard stops used on the horizontal ducts to prevent tube separation were removed and expansion limits maintained with cables. This eliminated the pull-out problems experienced earlier when advancing the tunneler. Polyethylene sleeves were inserted in the ducts to facilitate sliding. Hard stops were installed on the opposite ends to limit tube contraction. The separation of the flow at the fan inlet was eliminated by the addition of a 2-m straight expanding duct between the fan and the elbow where the vertical tubing exits the surface (Fig. 7). This had the added benefit of simplifying the positioning of the fan assembly, as its placement at the access hole in the surface was no longer as critical, resulting in reduced setup times.
